**ENVIRONMENTAL MEMORANDUM**

**Red Chris Development Company Ltd.**  
200–580 Hornby Street, Vancouver, BC V6C 3B6

Date: December Jan 5, 2016

Re: Red Chris Monitoring Committee Environmental Report Dec 23, 2015 – Jan 5, 2016

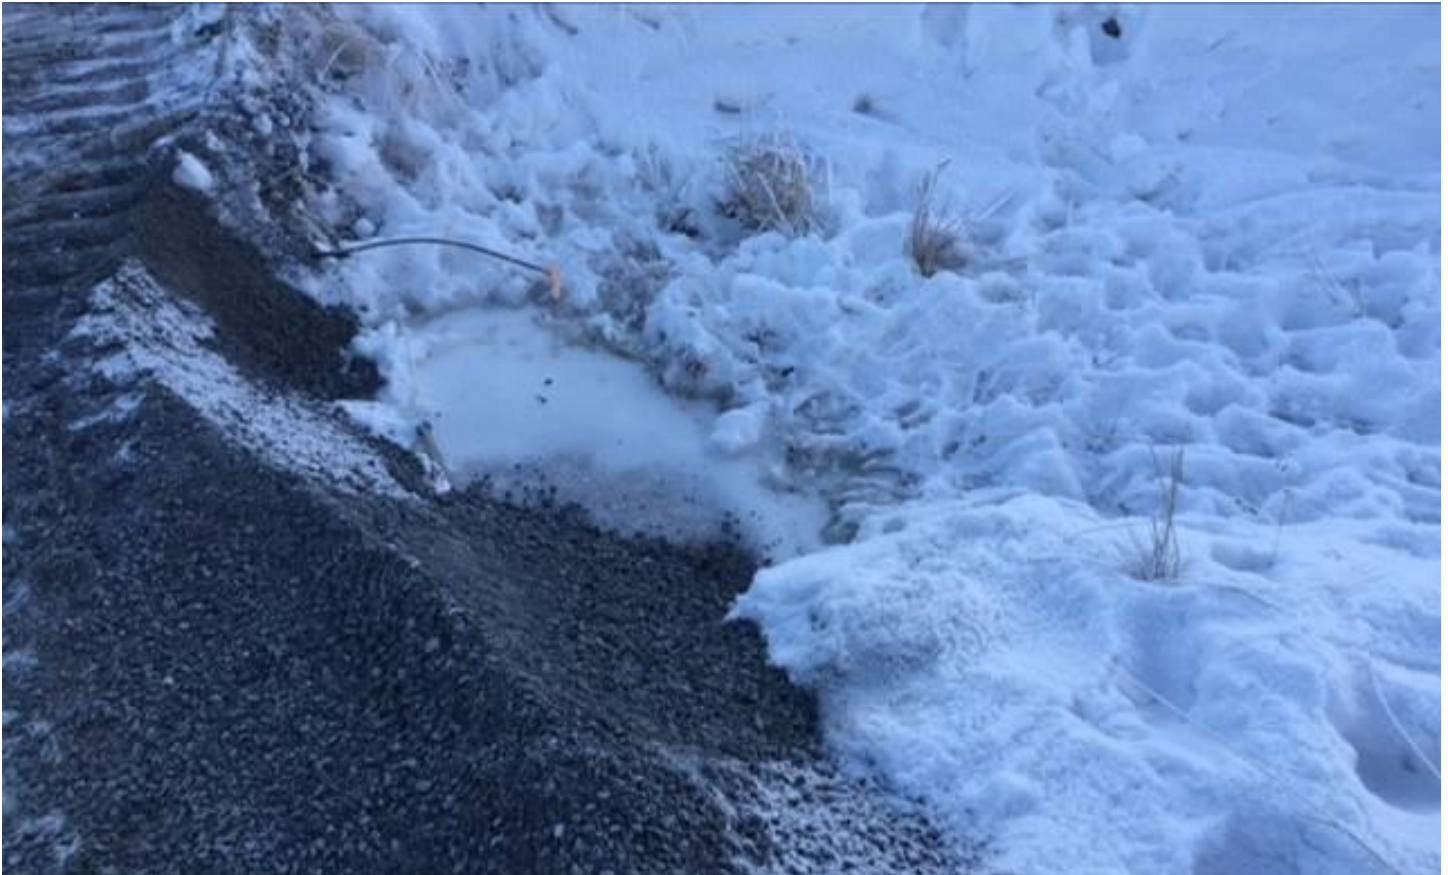
- After review of the data following the pit sump incident it was determined that impact to the environment was minimal and the daily sampling will be reduced to weekly for the time being. There will be a 5 samples in 30 days program set up during the spring melt to monitor any water from the sump that had frozen.
- Completed the 2015 groundwater monitoring program.
- Routine bi-weekly sampling. One site, W69, was completely frozen and no sample was taken.
- Collected most of the January monthly surface water samples.
- A road was built crossing Camp Creek at the headwaters near the pit to create access for a new radio repeater station. The current crossing is not environmentally friendly and will most likely cause problems in the future. There is a plan to have a proper crossing such as a small bailey bridge installed (figures 1 & 2).

**Figure 1:** Dec 21 – The upstream side of the Camp Creek crossing.

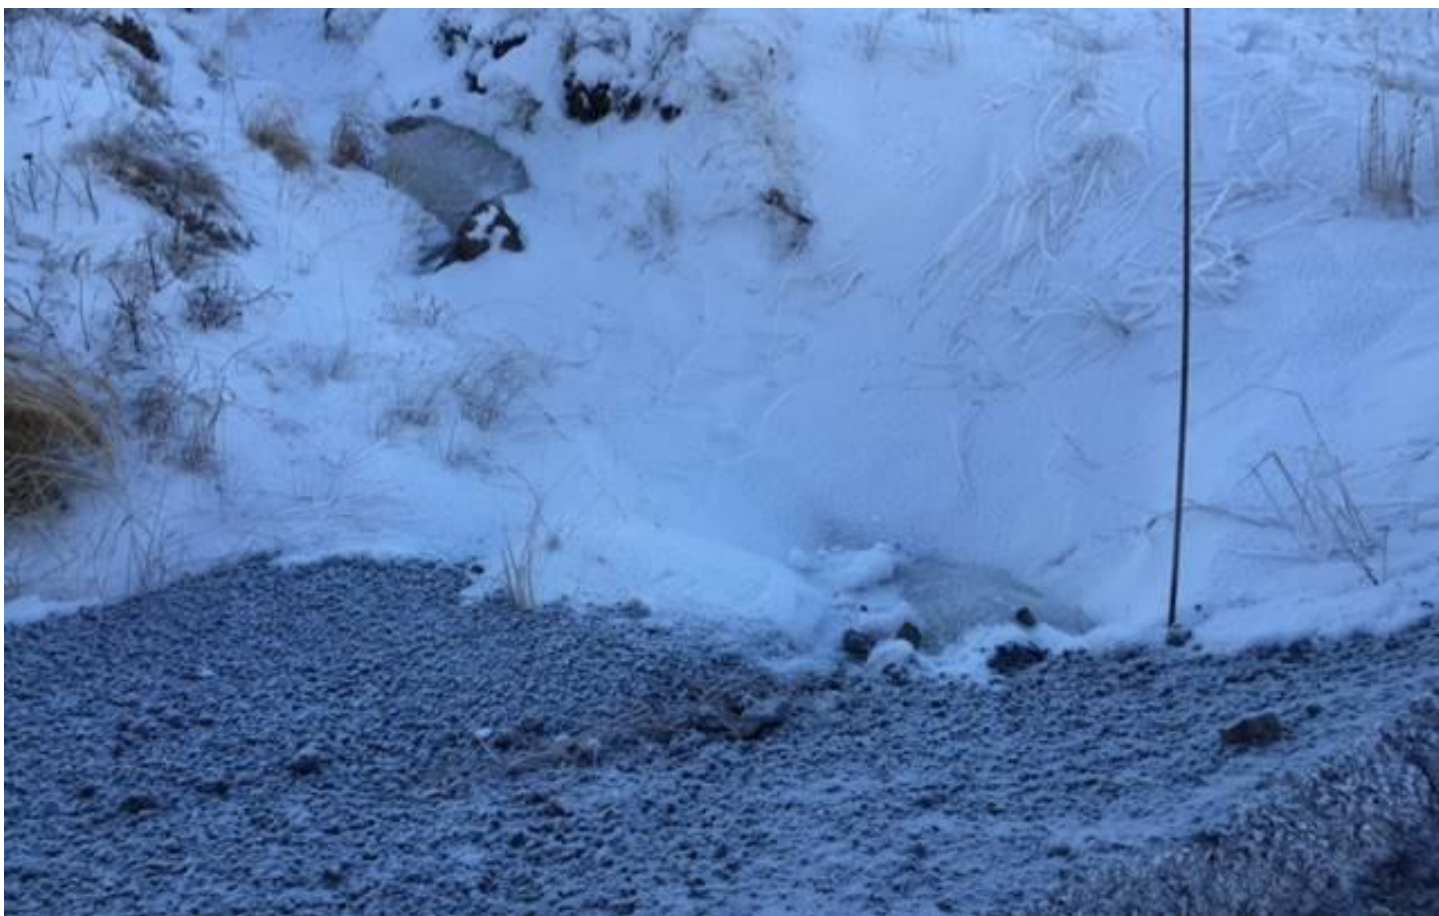
**Figure 2:** Dec 21 – The downstream side of the Camp Creek crossing.

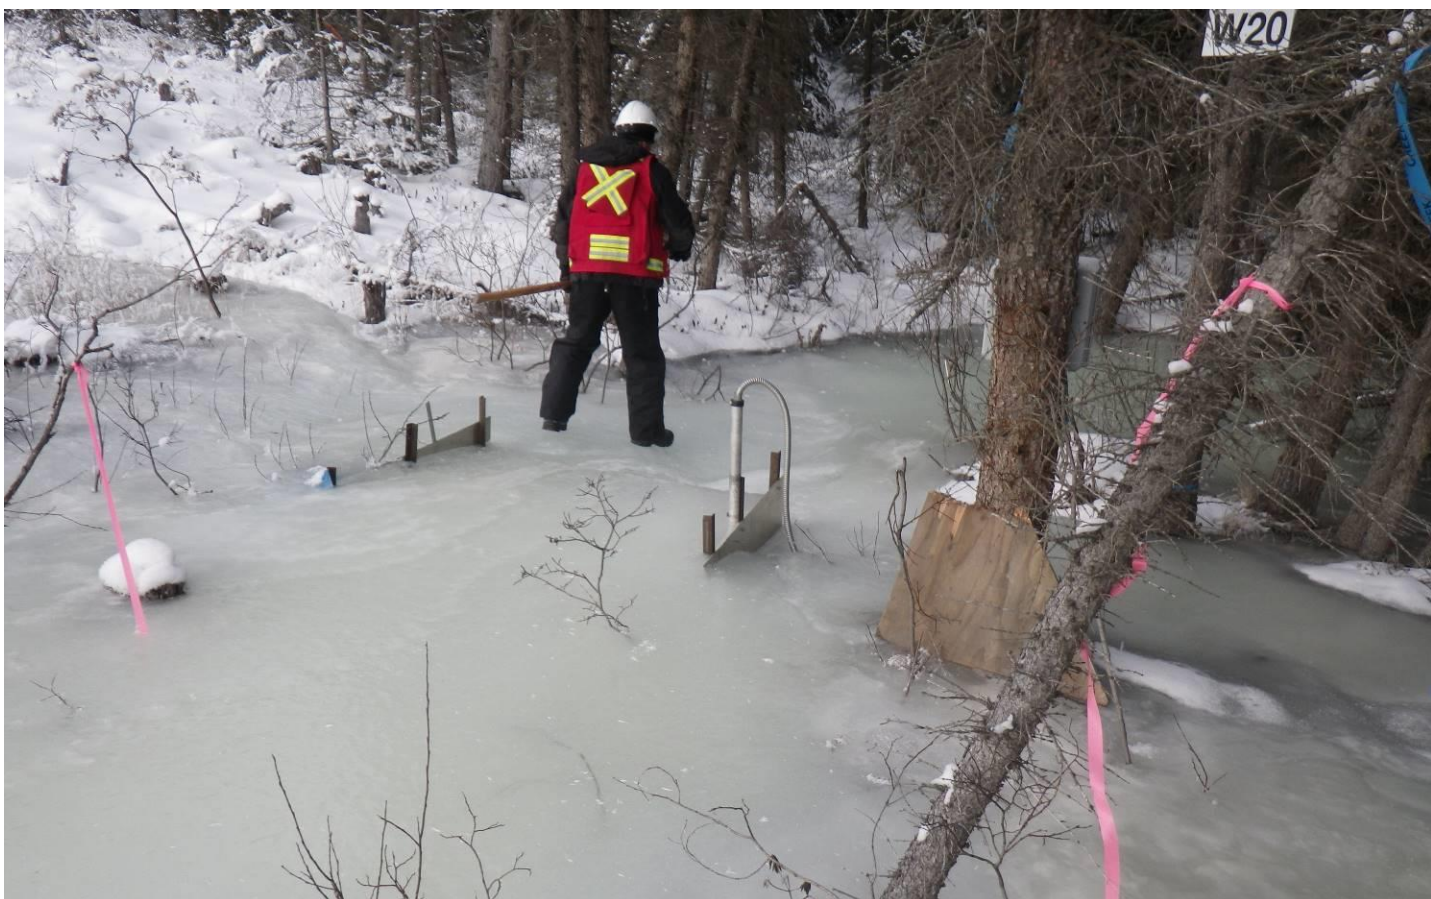
**Figure 3:** Jan 3 – Sample site W20. Lots of creeks have been freezing like the above photo.

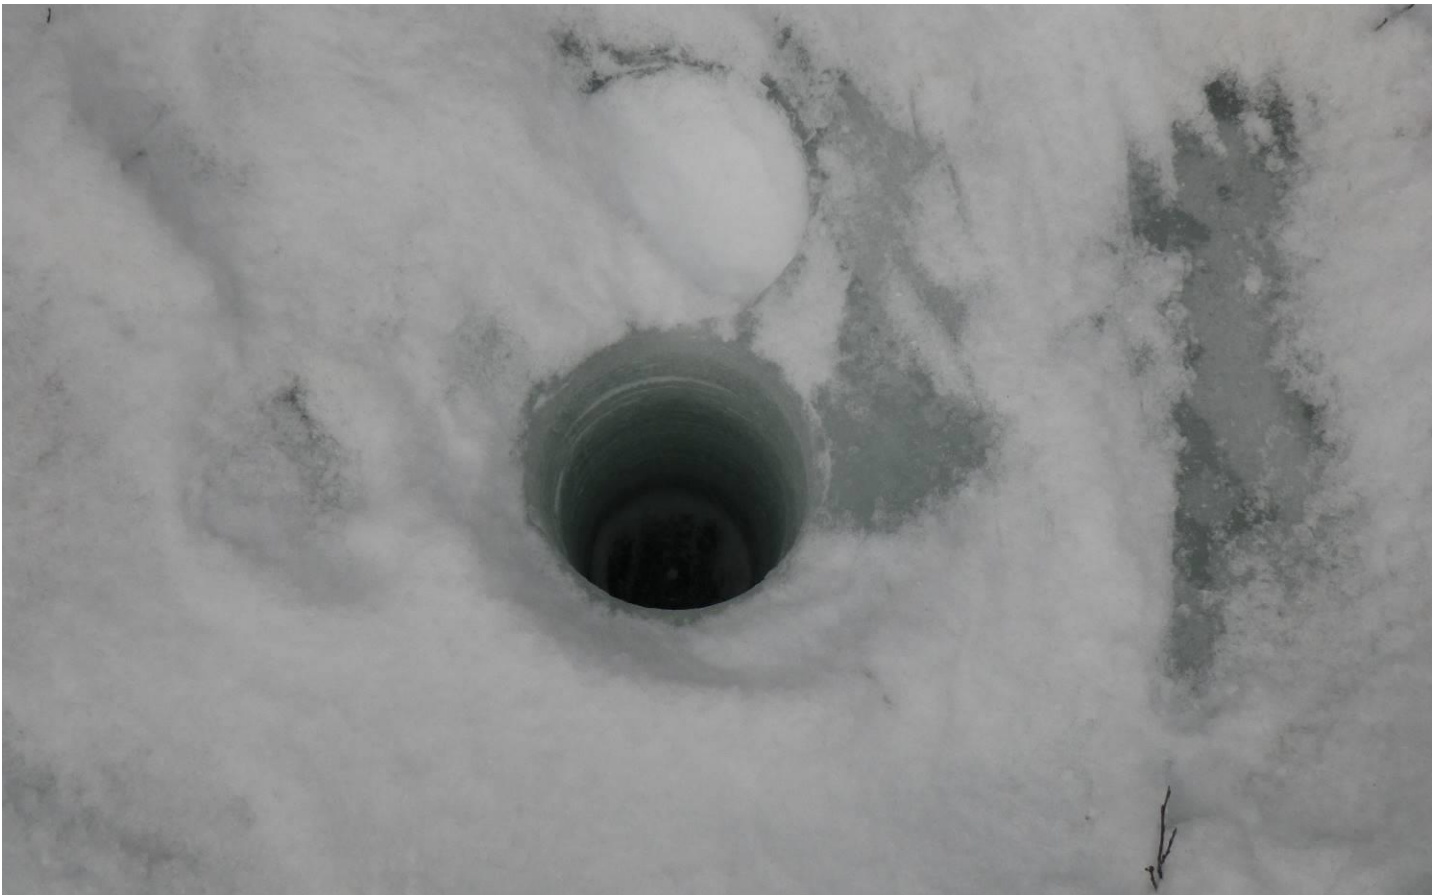
**Figure 4:** Jan 3 – Site W30 30 to 40 inches on ice on streams, the lack of snow which provides thermal protection for flows has caused streams to freeze solid and over flow the banks

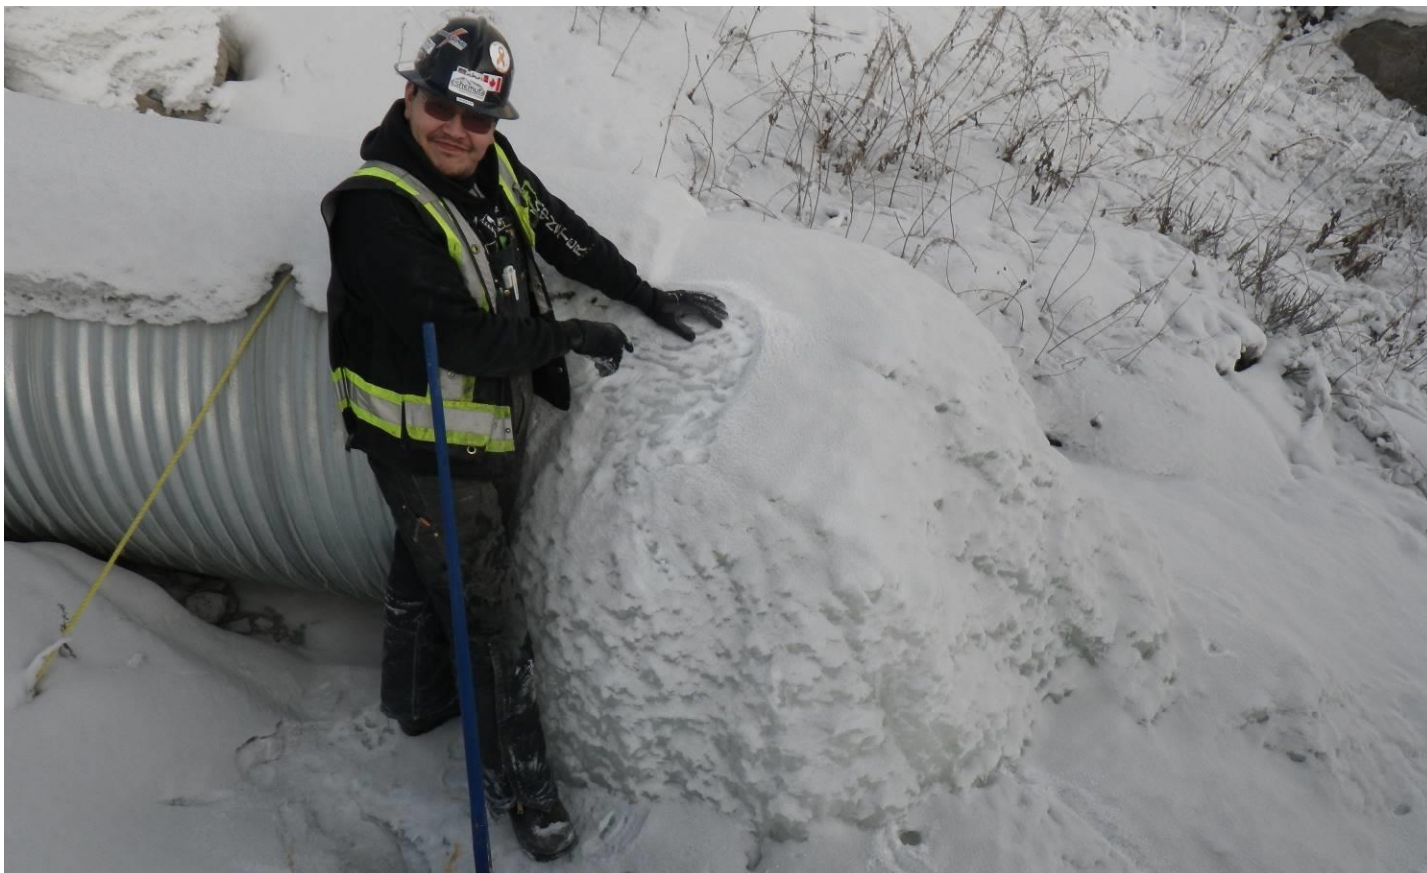
**Figure 6:** Jan 2 – Water freezing, such as here at W8, makes it very difficult to take water samples.

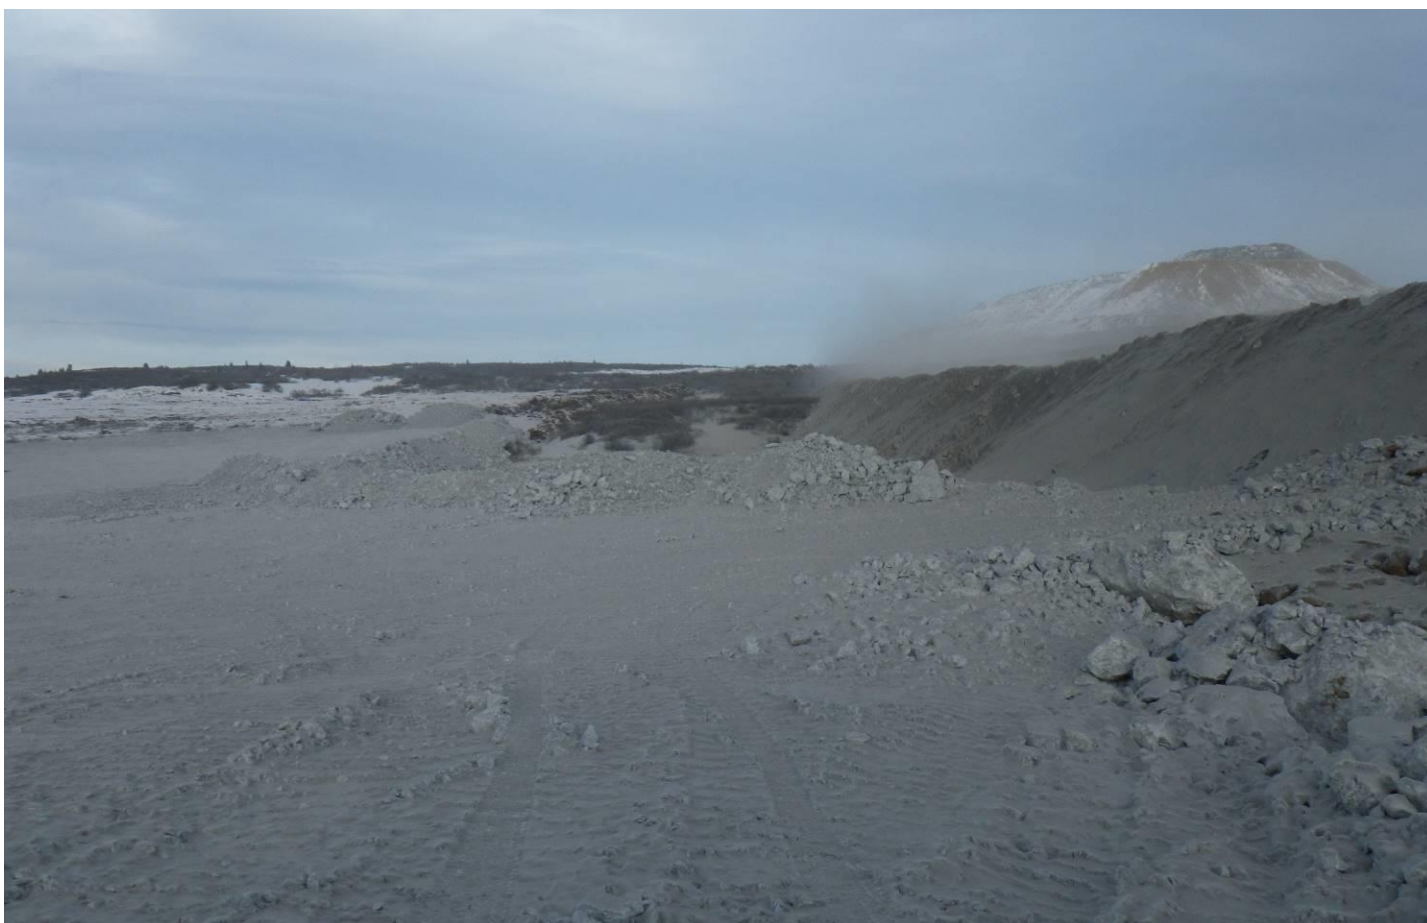
**Figure 7:** Jan 2 – Water sample site W79 has been buried by construction.

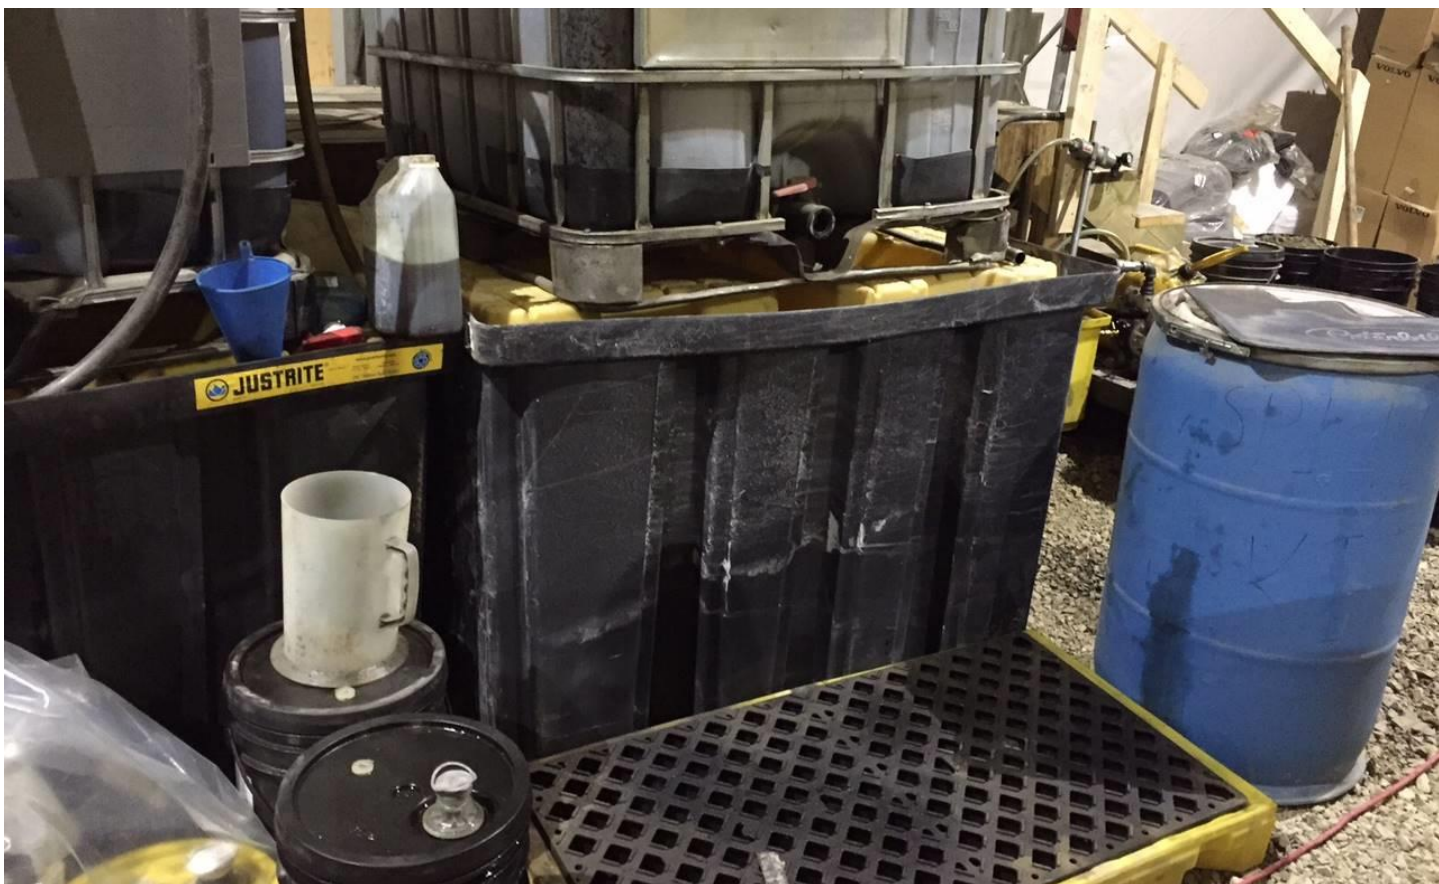
**Figure 10:** Dec 28 – Also at TNDC's shop. A waste oil cube is now on 110% secondary containment.

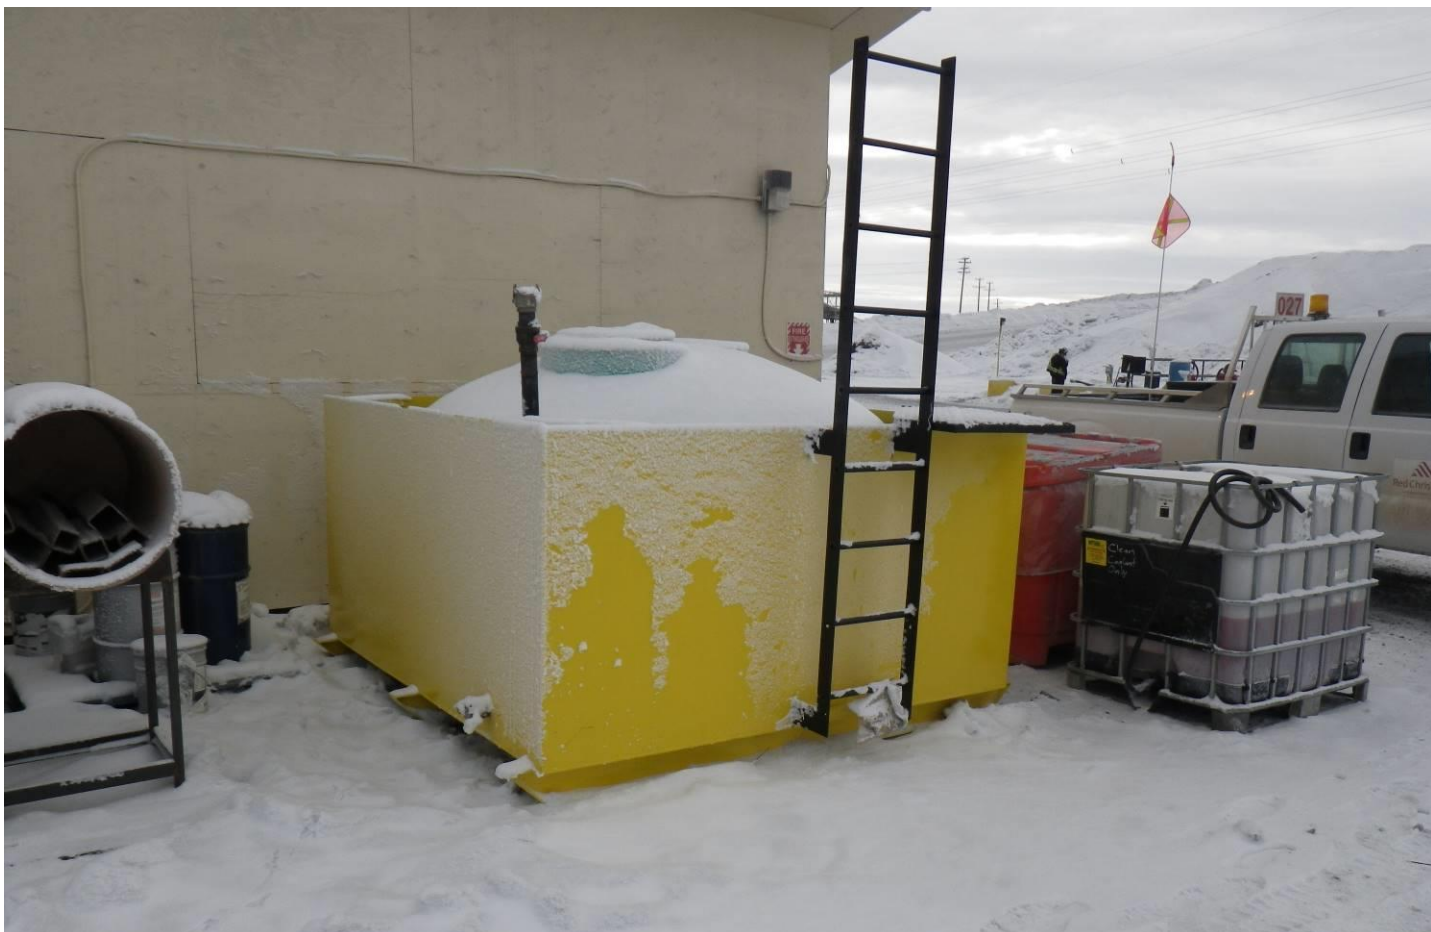
**Figure 11:** Jan 1 – Secondary containment for stored antifreeze has been built. A cube of antifreeze is also sitting out in an area with high traffic and no secondary containment. The pit shop has been asked to move it.

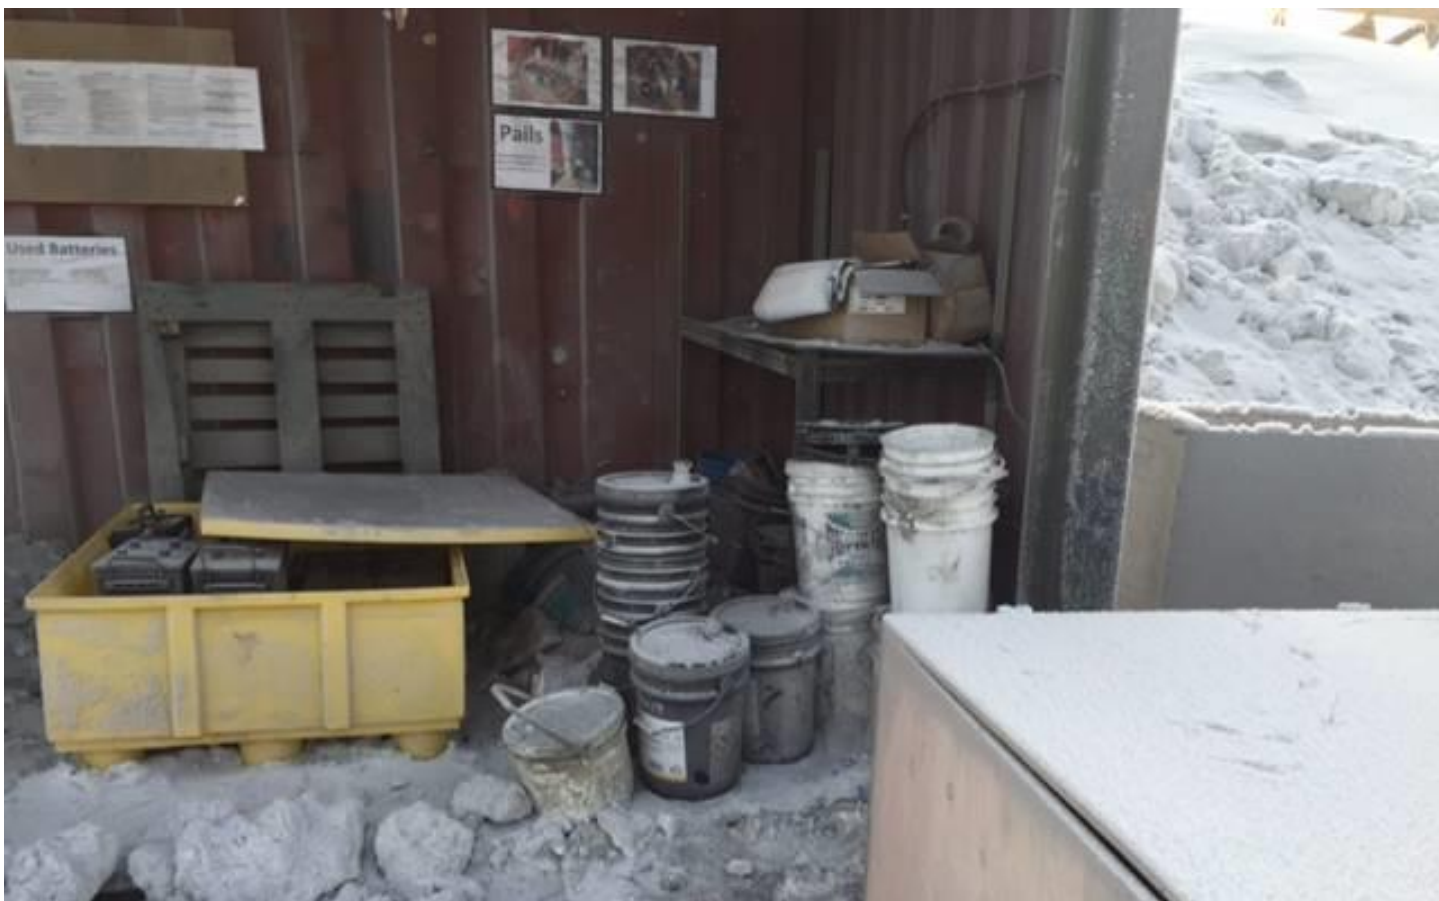
**Figure 12:** Dec 31 – Buckets sometimes are stored improperly at the waste area.

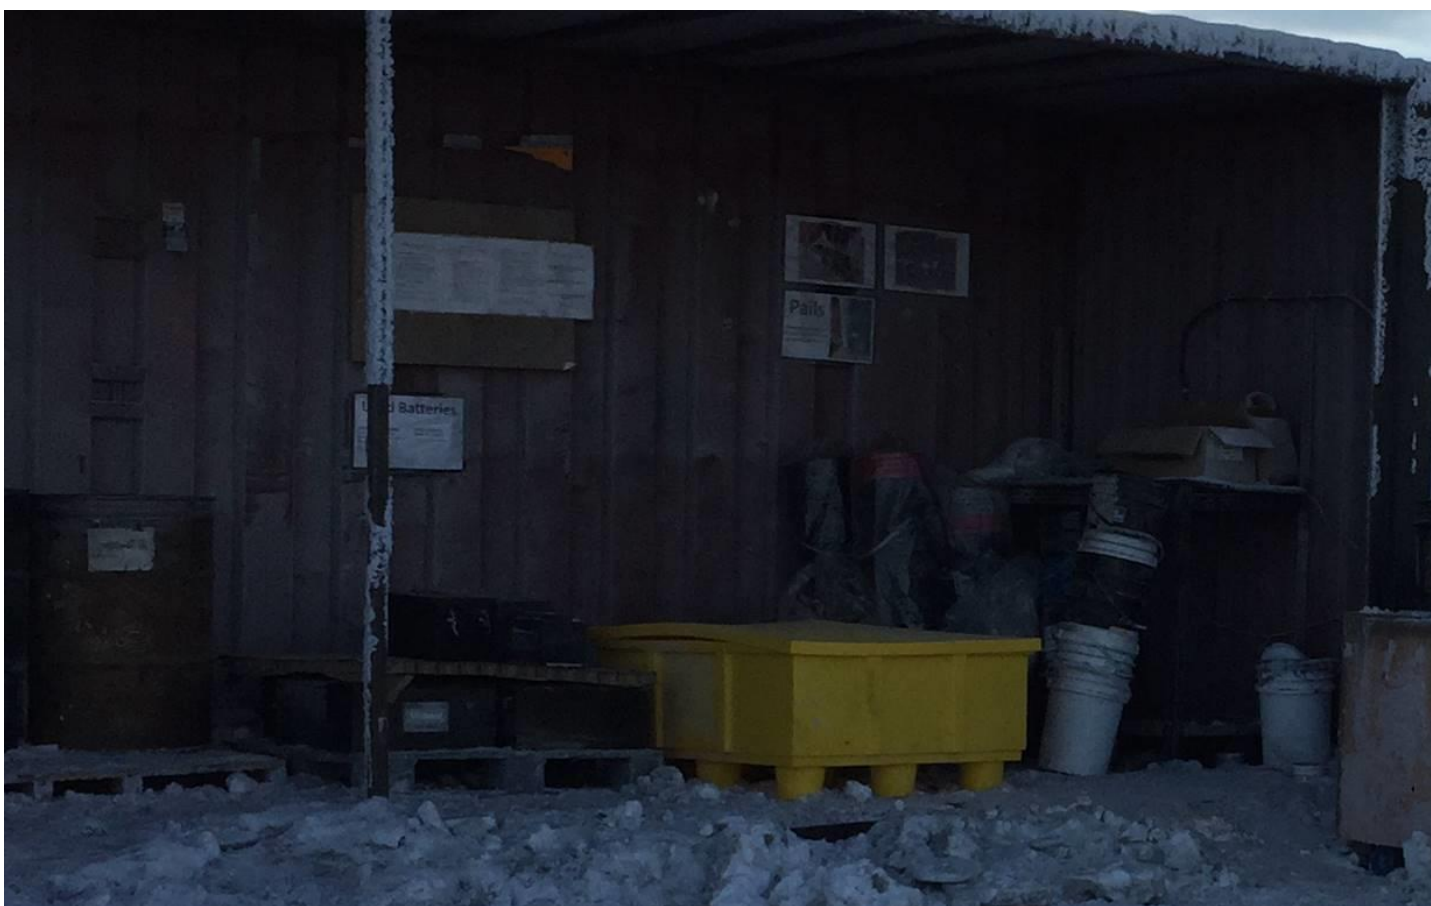
**Figure 13:** Dec 31 – The contaminated waste seacan after a little housekeeping.

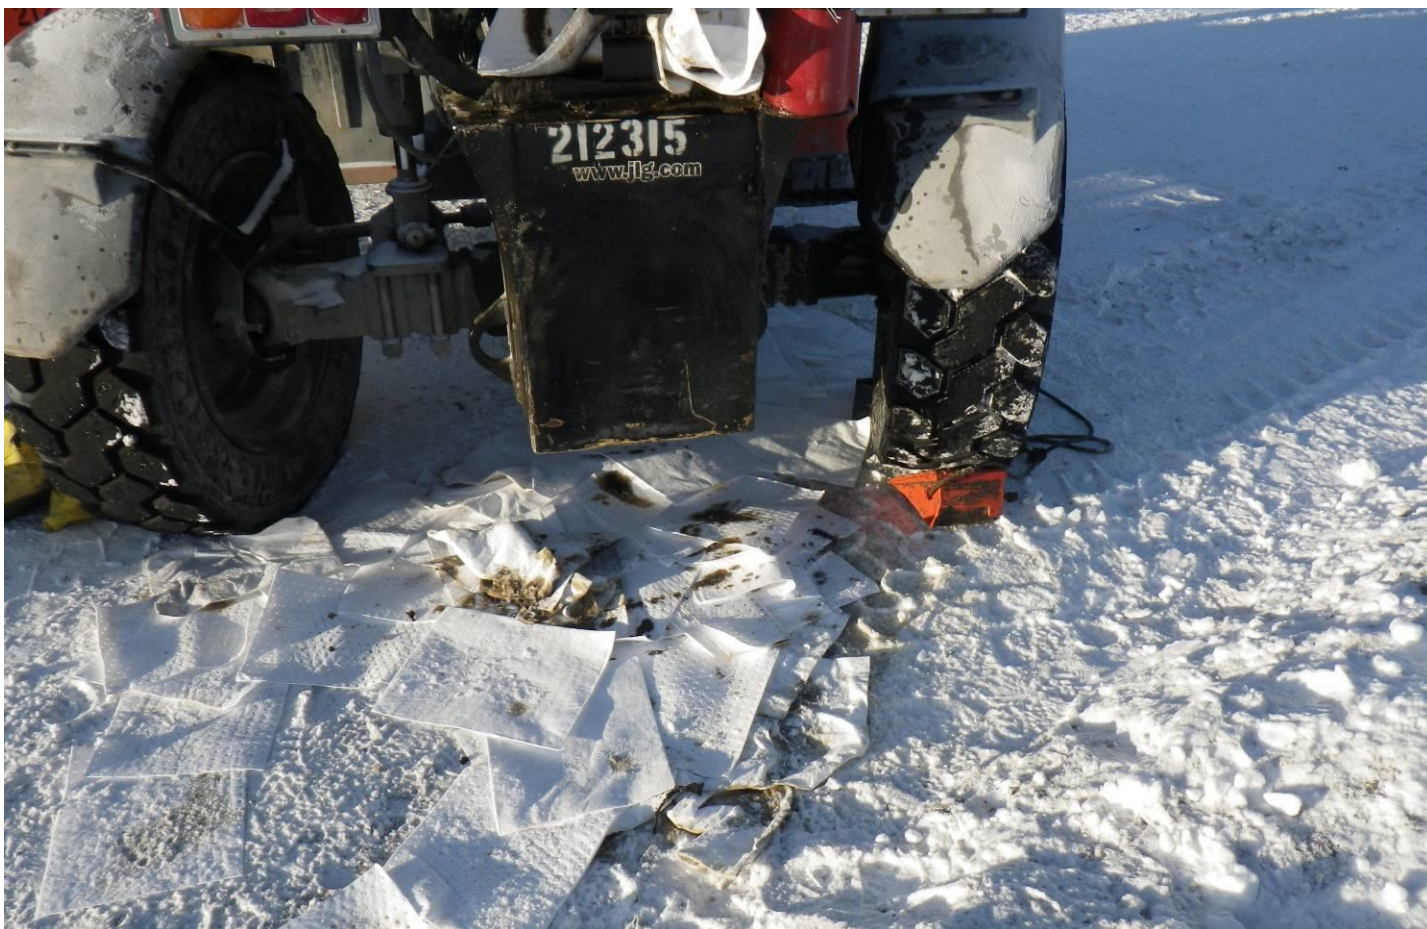
- Dec 30, 2015: 4 L hydraulic oil spill in the old TIA road (figure 14).
- Jan 2, 2016: 500 L diesel spill in the main zone of the pit. PEP reportable. DGIR #: 152806 (figures 15 & 16)
- The spill in the trailer from last report on December 18<sup>th</sup> has been cleaned up (figure 17).

**Figure 14:** Dec 30 – Zoom boom hydraulic oil spill in the TIA.

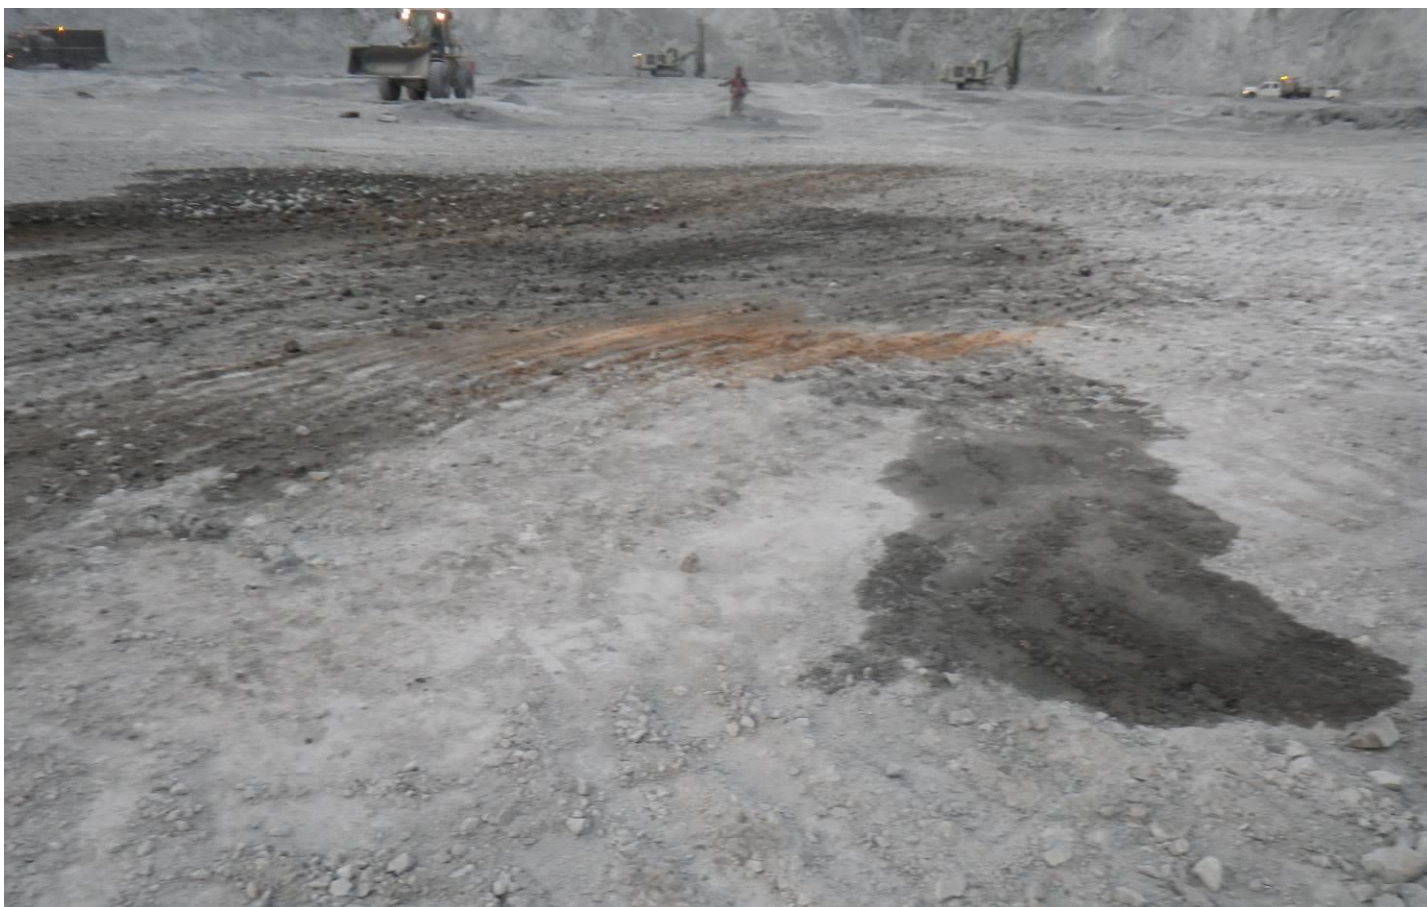
**Figure 15:** Jan 3 – Spill from the haul truck that leaked approximately 500 L of diesel.

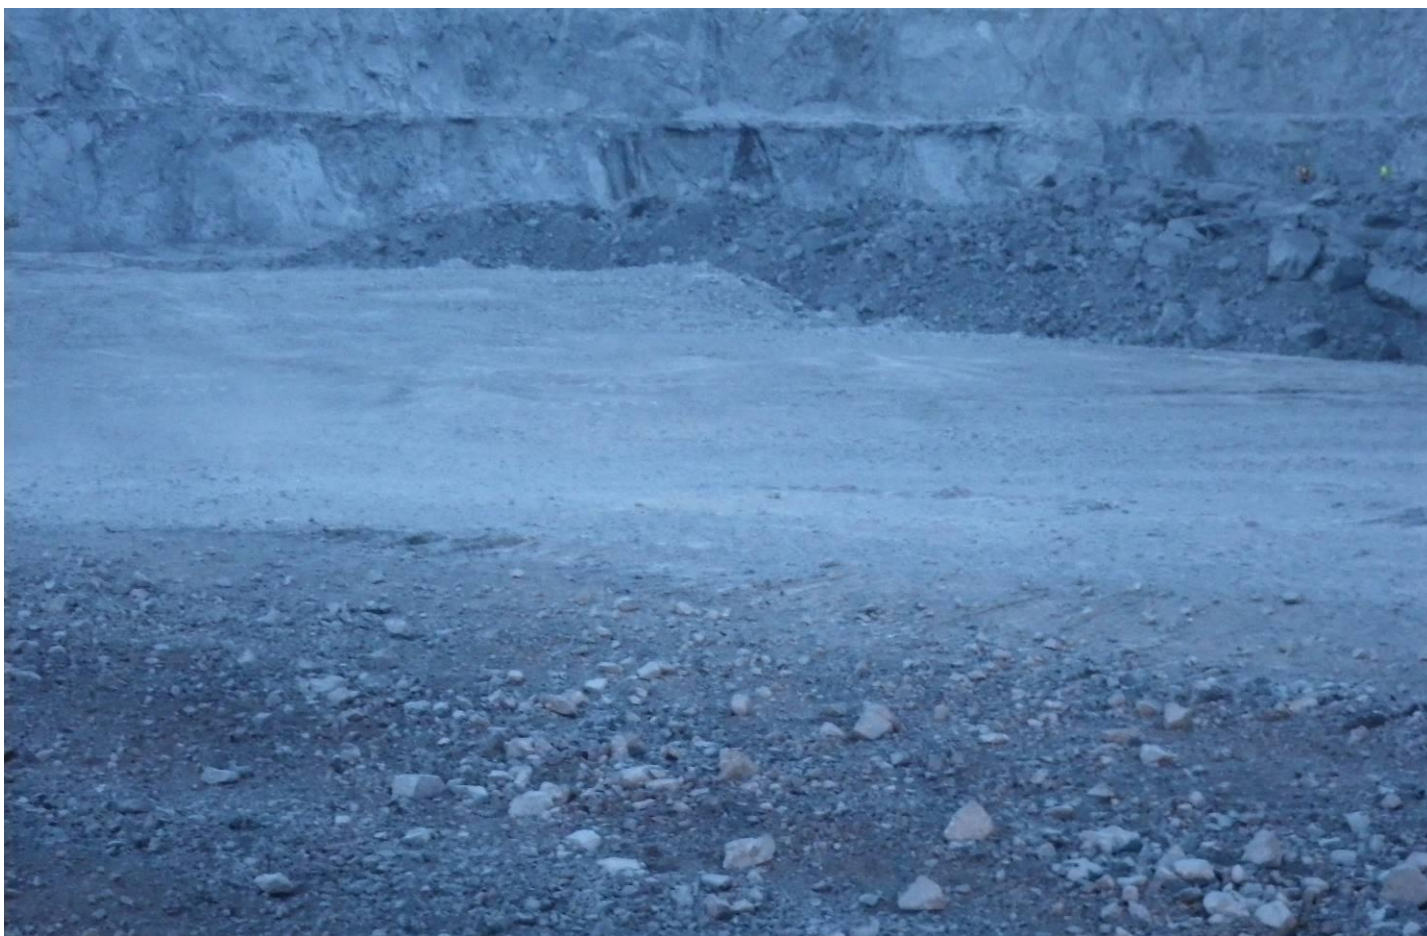
**Figure 16:** Jan 3 – After cleanup. Note: There was a blast between when the cleanup occurred and the phot was taken.

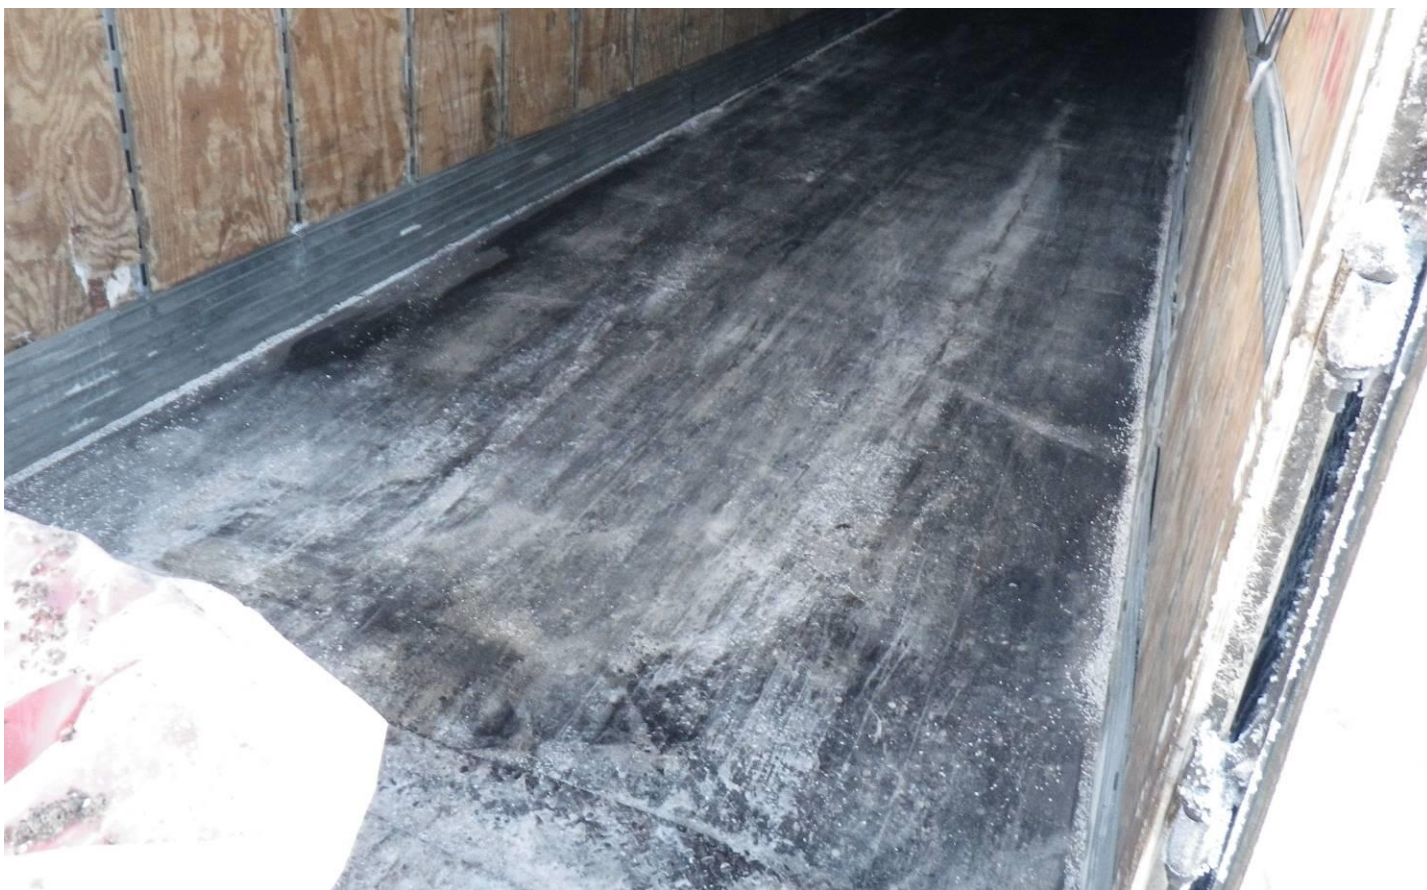
**Figure 17:** Dec 23 – The trailer that had a oil cube puncture has been cleaned up very well.

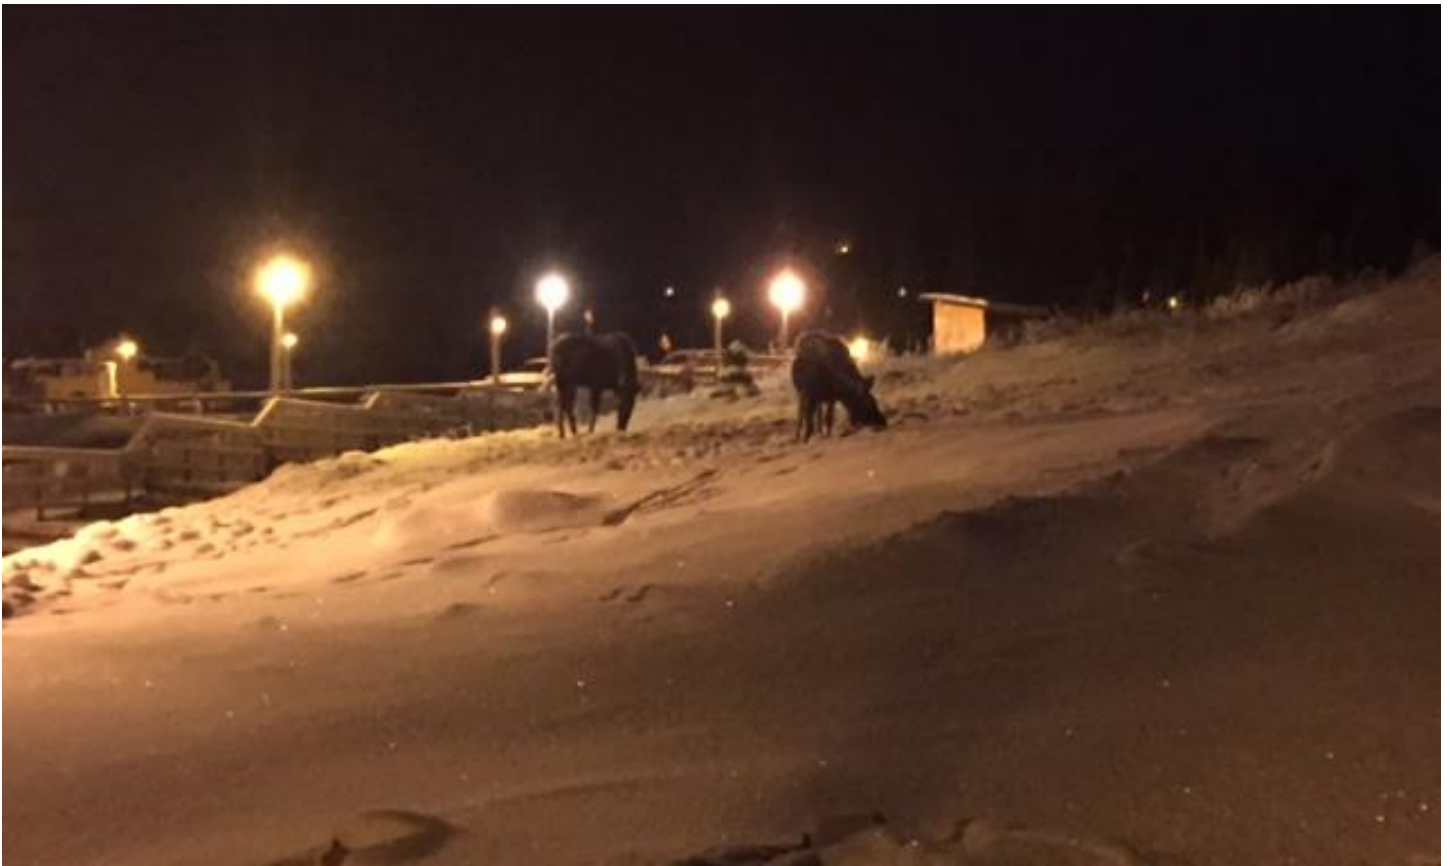
- A cow and a calf moose continue to graze near the West and South sides of the bunk houses. They normally appear at the end of every other day to feed on the vegetation. They have become habituated and won't leave when people are nearby. Attempts to scare them away, with air horns and bear bangers, are being made but have been ineffective. They have been attracted to the salt on the walkway between the camp bunks and parking lot. They've been seen less and less now since about the 28<sup>th</sup> (figure 18).
- Dec 22 – A black fox was spotted on the old TIA road at 1 km.
- Dec 29 – A wolverine was seen behind the PAG dump during night shift. It was just passing through.
- Jan 1 – A fox was having a nap near the fuel bay in the TIA (figure 19).

**Figure 18:** Dec 22 – The cow and calf moose grazing near the back parking lot.

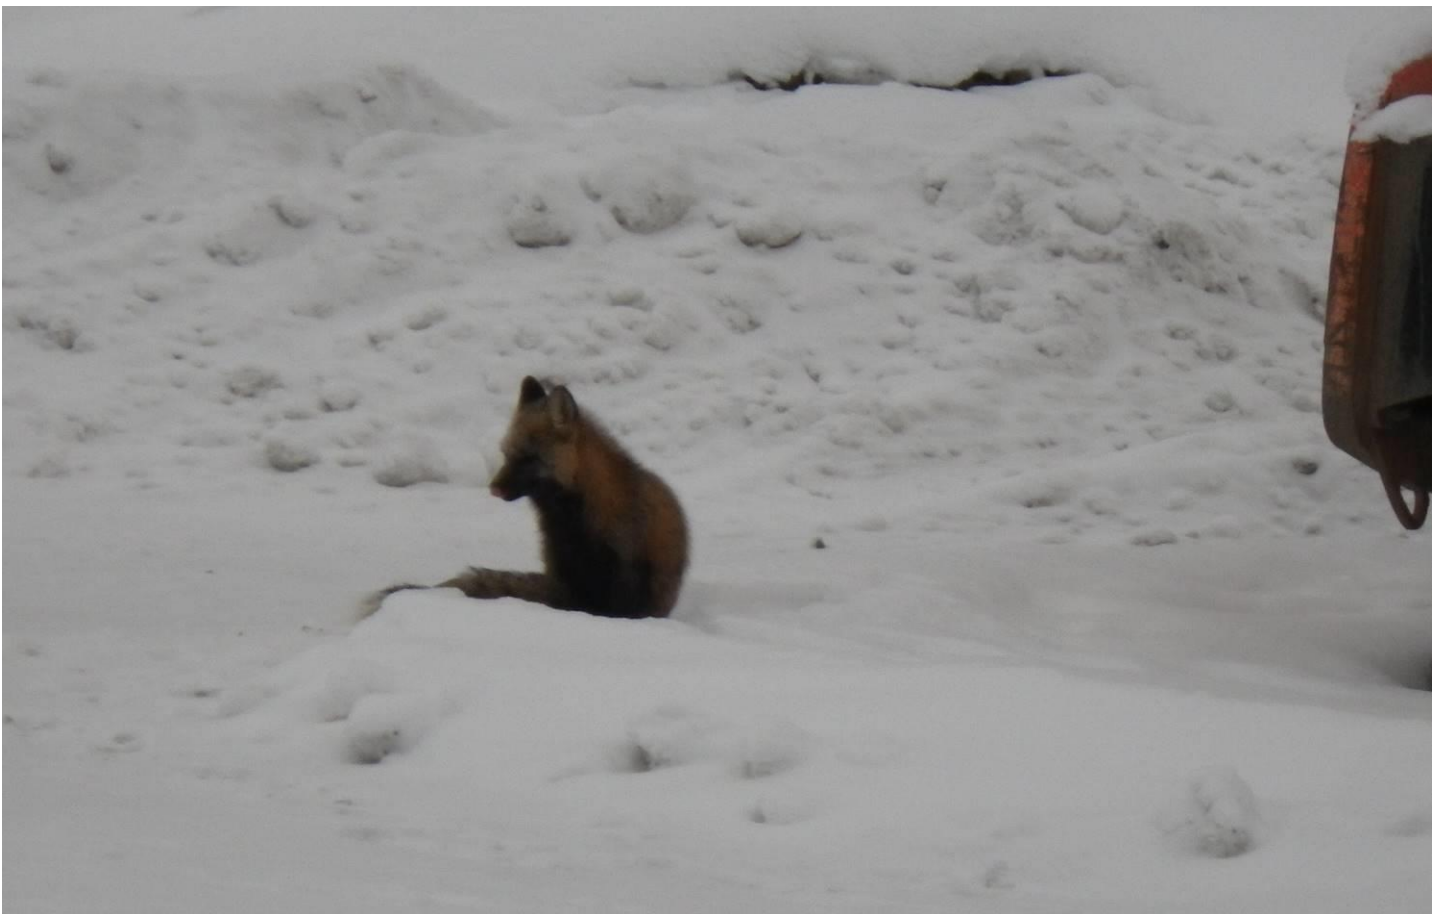
**Figure 19:** Jan 1 – A fox was sleeping near the fuel tanks in the TIA.
